# Site Report and Management Plan

East Hill Farm Site, Corvallis OR

Kaden Flick – GEOG 452

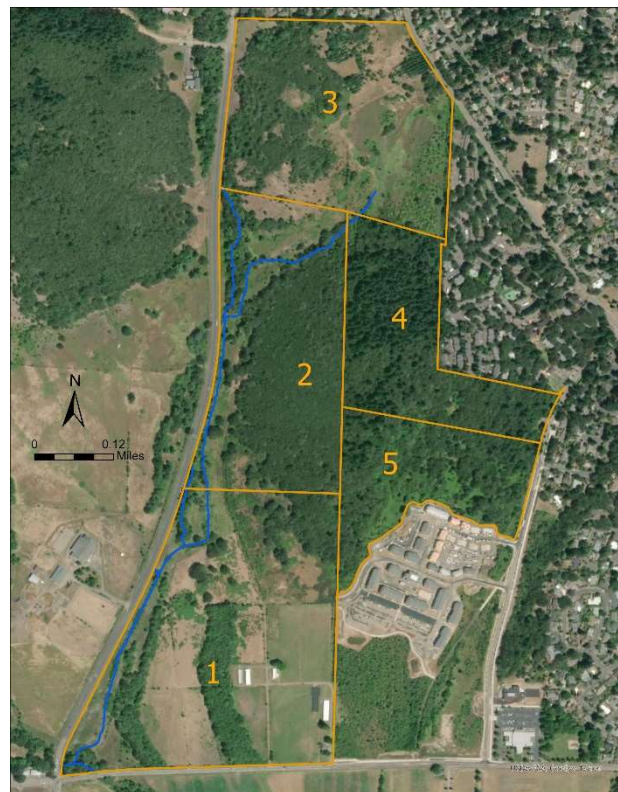
Figure 2: Map of site showing individual taxlots and aerial imagery. Blue lines indicate locations of Lamprey and Oak Creeks and smaller tributaries.

The entire site is composed of four taxlots, however some unofficial trails lead onto Taxlot 5, pictured on Figure 2 in the lower righthand corner. For the purposes of this report, this taxlot will be included in all following maps to provide a clear view of local activity in and around the site, even though the site is not part of the management area. The following table shows information about each individual taxlot on the site, as well as relevant totals. Please note that the acreage information displayed in the table is total acreage. Taxlots 1, 2, and 3 each extend beyond the borders of the site. In order to keep market value accurate, the entirety of each taxlot was included in the table. The total acreage contained within the site is listed under “Adjusted Total” in Figure 3. Market value for the adjusted acreage was not assessed.

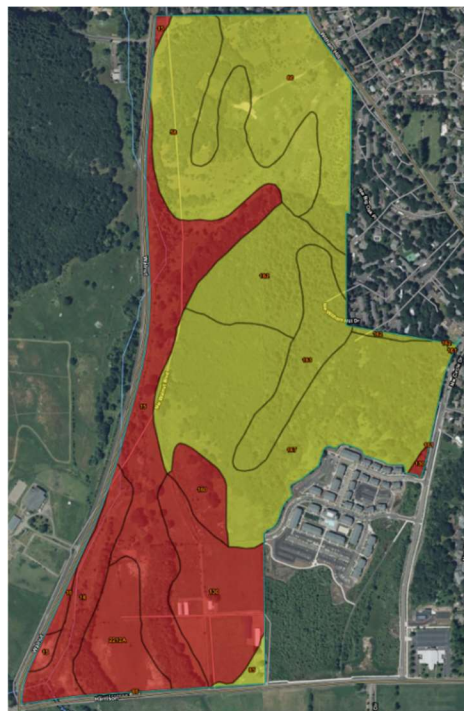
The figure at right shows the site's suitability for recreational paths and trails based on soil type according to the United States Department of Agriculture's (USDA) Web Soil Survey. The yellow areas are composed primarily of Dixonville-Gellatly complex and Dixonville-Gellatly-Witham complex and are rated as "somewhat limited" in their ability to support trails. The red areas are composed primarily of Barshaw clay and are rated as "very limited" in their ability to support trails.

Figure 4: Map showing soil suitability for supporting trails.

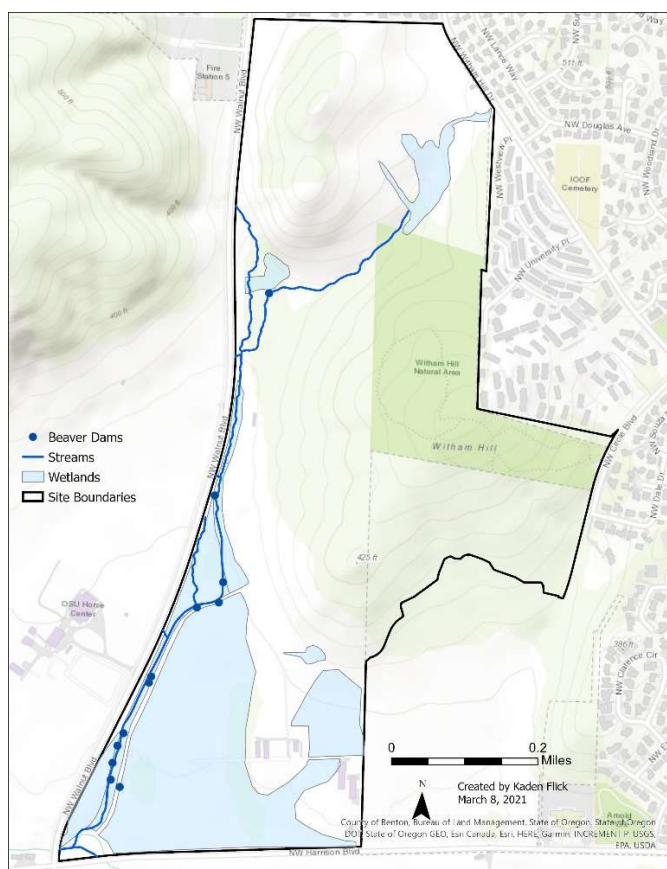
The site contains numerous wetland areas and streams. There are two main streams on site, shown in Figure 5 as dark blue lines. Lamprey Creek runs north to south down the west side of the site and Oak Creek, which enters and quickly exits the site in the lower southwest corner. Wetland areas are found on most flat or gently sloping terrain on site. Wetlands are shown in a light blue color in Figure 5. There are also numerous beaver dams on site, shown on Figure 5 as dark blue dots. There are few hydric soils on site, found mostly in the gently sloping areas near wetlands (United States Department of Agriculture, n.d.).

Figure 5: Map showing hydrological features on site.

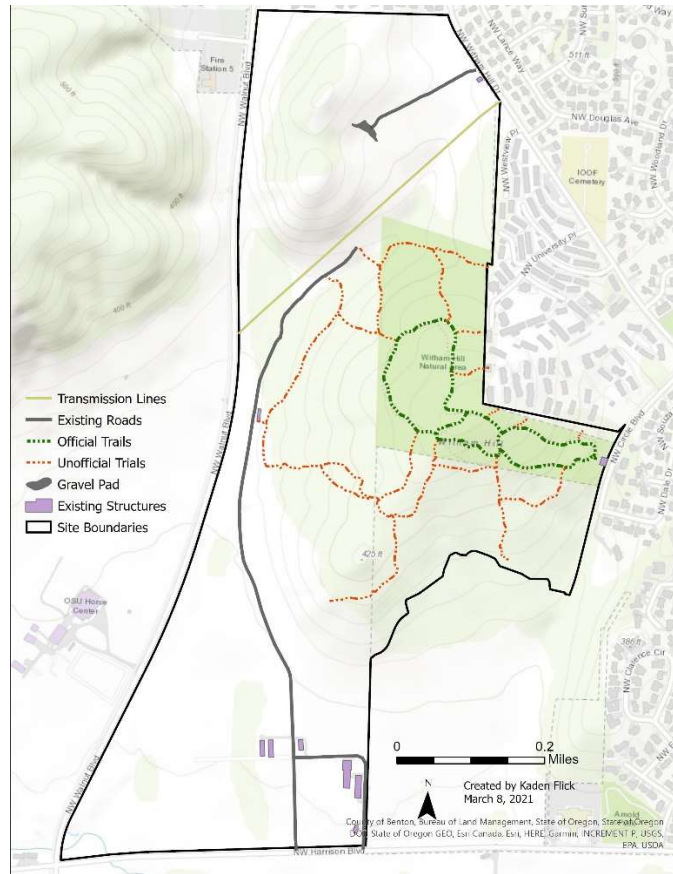
There are several structures present on the site. Taxlot 1 contains several barns and one residential structure related to ongoing turkey research by OSU. Taxlot 2 contains a dilapidated barn, presumably remnants of previous agricultural activity on the site. Taxlot 3 contains a small OSU research station and another old barn. Taxlot 4 is the site of Witham Hill Natural Area and contains a small parking lot and trail system. At the trailhead there are bike racks and a small informational sign that displays a trail map and other information useful to a visitor. Throughout are old roads and fences, some of which are still in use, particularly in Taxlot 1 where OSU maintains active pasture. Remnants of old dams are present along Lamprey Creek and various irrigation canals on the southern end of the site. Large transmission lines also run from the western edge of Taxlot 2 to the eastern edge of Taxlot 3.

Figure 6: Map showing existing infrastructure on the site.

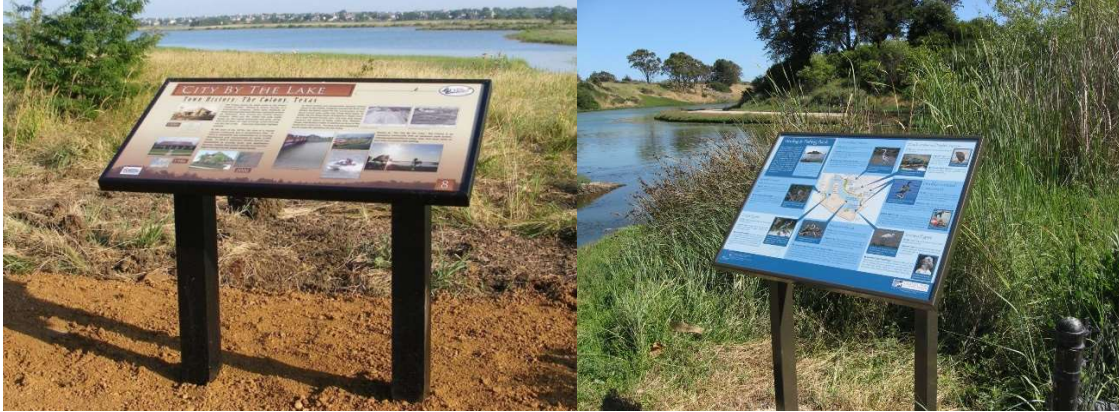
Figure 7: Examples of interpretive trail signs. Image Credit: Stuart Macdonald (Left) and Ryan Clark (Right)

There are also numerous opportunities for research and education on the site. The setting of the proposed trails lends itself well to a series of interpretive signs that detail information about the site and the things to be found there. Examples of topics for signage include: the importance of wetlands and wetland restoration, riparian areas and restoration, beavers and keystone species, invasive species removal, historical vegetation regimes both on and off site, and area history, including that of native peoples that have historically used the land. The number and diversity of invasive species present opportunities for research into removal and restoration of natives to the site. Existing fencing on the site could be used to contain grazing animals like cows, sheep, and goats. Proposed trails would also facilitate greater access to the site, allowing researchers to visit research sites more easily. Community outreach could take the form of a "Friends of" group that works with researchers to install and maintain research infrastructure and host cleanup days to remove invasive species.

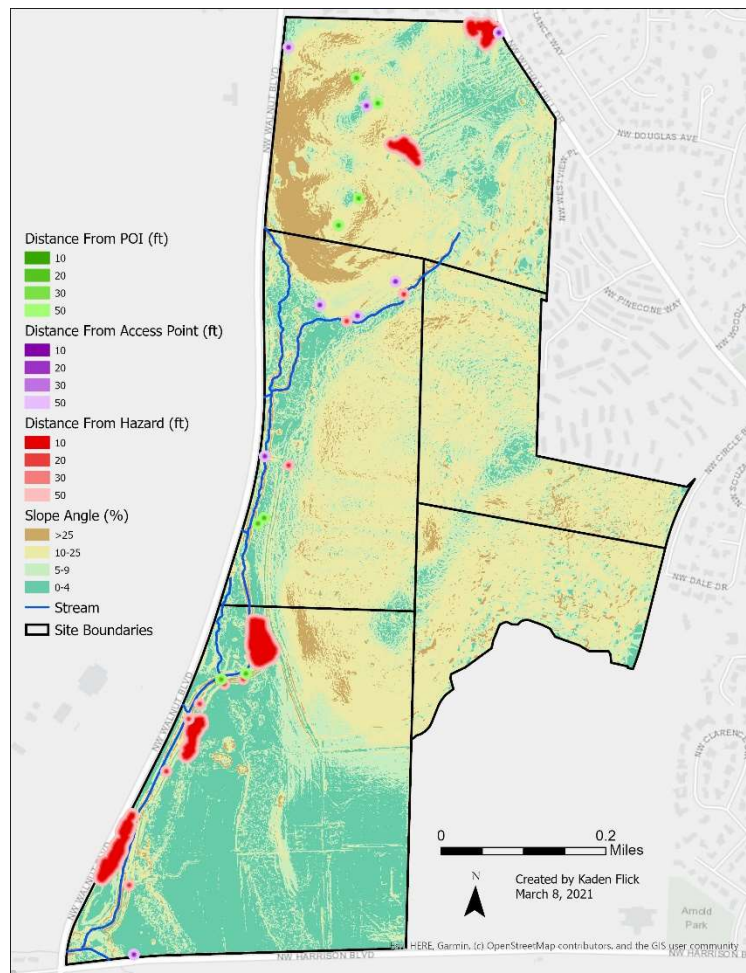
Below is the suitability analysis map created using criteria shown in Figures 8 and 9.

Figure 10: Suitability Analysis map.

After creating the criteria for each suitability analysis, a single map was generated in order to place both trails and a parking lot. There were two places that were suitable for a parking lot. The first was on the eastern edge of Taxlot 3 and the second on the southwestern edge of Taxlot 1. Both areas scored highly based on the criteria defined in Figure 9. However, after evaluation and preliminary routing of the trails, the location on the southwestern edge of Taxlot 1 was determined to be the most suitable location for several reasons. This location allows for a parking lot near where the proposed trail ends in the southern edge of the site. It is also the furthest location from any other established parking area on the site while also meeting the slope requirements. In addition, a parking lot in this location does not necessitate a trail running near the middle of Taxlot 3, which contains a large, unattractive crushed concrete pad, which is home to an ongoing OSU research project.

In Taxlots 1 and 2, it was found that using existing roads and dikes as trail surfaces satisfied the slope, viewshed, POI, and access point criteria well. Their placement does send them near hazards and sensitive areas, but mitigating those risks are straight forward. The major hazards in that part of the site

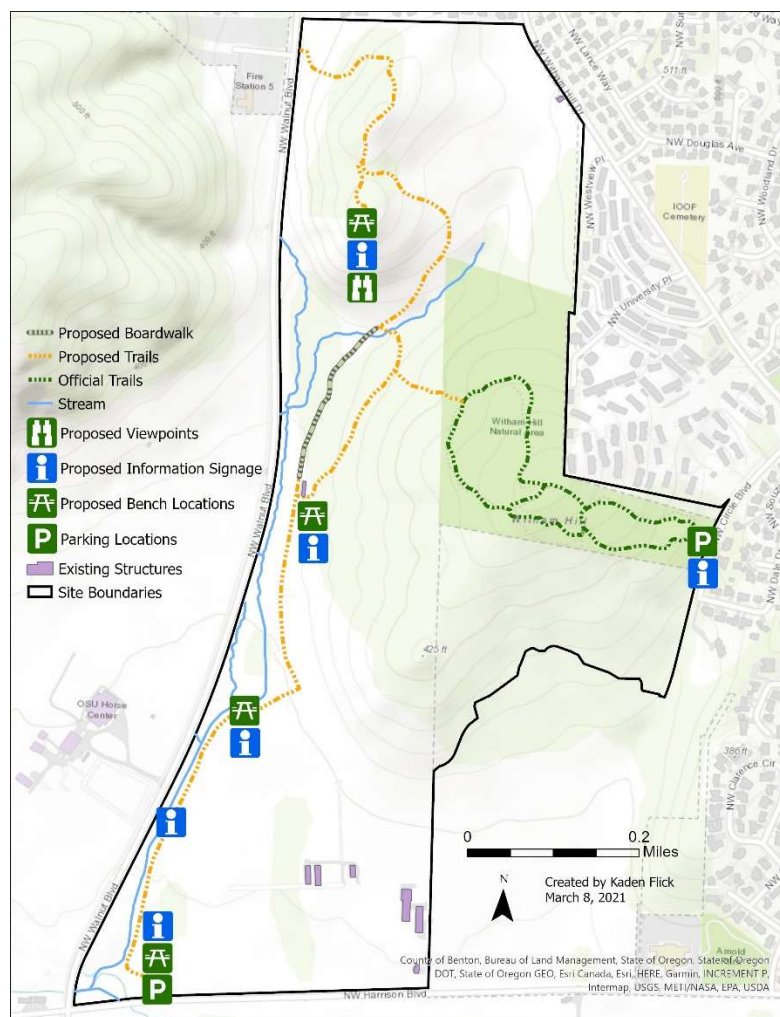
Below, Figure 11 shows the proposed placement of trails, benches, interpretive signs, and parking lot. Figure 12 shows a more detailed conceptual design for the proposed southern parking area, including the parking lot, picnic area, and trailhead sign.

Figure 11: Conceptual map showing placement of new trails, interpretive signs, parking area, and benches.

Using the suitability analysis criteria and map developed in Chapter 4, the trails were placed in locations that send them near points of interest on the site and away from hazards. The location of the boardwalk discussed in Chapter 4 is also included on the map. Two new trails branching off from the existing trails system on Witham Hill Natural Area were placed using data collected by the author and follow established unofficial trails on the site. These unofficial trails meet the same criteria that were used for the remainder of the trails. Potential sign and bench locations are also included on the map. Locations for signs were chosen by their proximity to areas of interest like beaver dams, notable wetlands, and viewpoints that would be relevant to the signage at each location. Bench locations were selected based on their proximity to points of interest and distance from each other along the trail. Because the proposed trail system has yet to be laid out on the ground – particularly in the northern portion of the site – additional resting benches may be appropriate in areas with challenging terrain. In order to make the proposed trails accessible to all, trails should have a clear tread width of at least 36 inches and be free of obstacles that would make transit difficult for those in a wheelchair (Zeller et al., 2012). Trail surface should be a hard packed material that allows for easy transit. Due to the relatively unsuitable

soil for supporting trails on the site, crushed gravel is recommended (Zeller et al., 2012) to provide a stable surface that will not turn into a mud pit when wet.

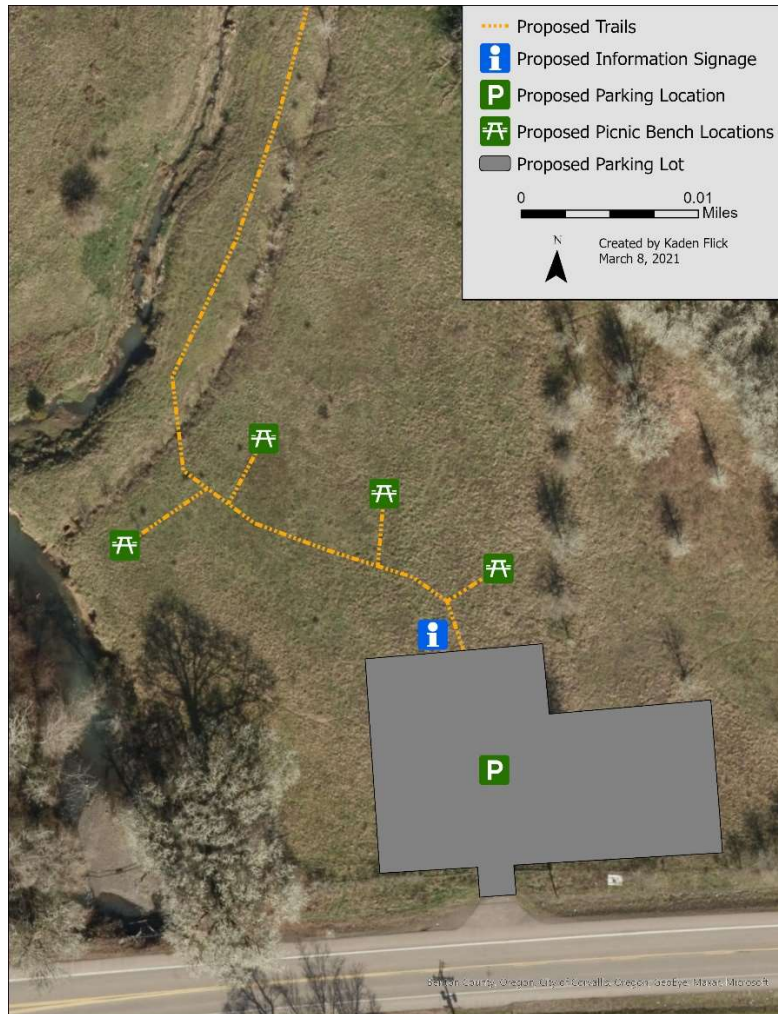
*Figure 12: Conceptual map showing a detail view of the proposed parking lot and associated picnic area.*

Figure 12 is a detailed map of the proposed parking area. The location for the parking lot was chosen based on the criteria and methods discussed in Chapter 4. Potential locations for a network of picnic benches were also included on the map. The exact number and placement of these benches is not concrete, and likely to change. The map is intended to provide an example of what the area could look like. The parking lot area does not necessarily need to be paved. To keep the number of impervious surfaces on the site to a minimum, gravel can be used to keep the parking area free of ruts and large muddy areas.
